# THE RECONSTRUCTIONIST

## AN ACCIDENT RECONSTRUCTION NEWSLETTER

### Who Was Driving? – Crashed, Overturned and Burned!!

Woodrow M. Poplin, P.E.

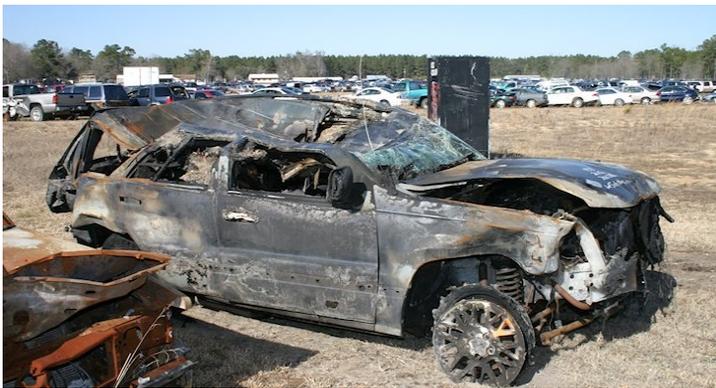
Approximately 15 minutes after midnight on a cold December morning, a Jeep Cherokee SUV drifted off a two lane roadway. The driver corrected back to the left and lost control. The Jeep Cherokee crossed the roadway to the left shoulder where it collided with a tree. It was redirected back across the roadway to the right shoulder/ditch area where it overturned onto its roof and burned. Both occupants were fatally injured. The vehicle owner remained inside near the driver seat. His friend was partially ejected out of the rear hatch. **The police concluded that the owner was driving. The owner's family insisted that the friend frequently drove the Jeep. The task was to determine who was driving.**

The Jeep Cherokee engine compartment and most of the interior were largely consumed by fire. During the examination, the following was noted:

- The initial collision produced a lateral force at the passenger front of the vehicle. It was followed by rotation, overturn and a final collision at the rear with the ditch bank.
- The driver seatbelt receiver was empty.
- The driver seat was further rearward than the passenger seat.
- The driver seat was adjusted for a large individual.
- The driver seat back was forced rearward and twisted toward the rear.
- Torn khaki material was laying on the driver seat.
- The passenger seat was undamaged.

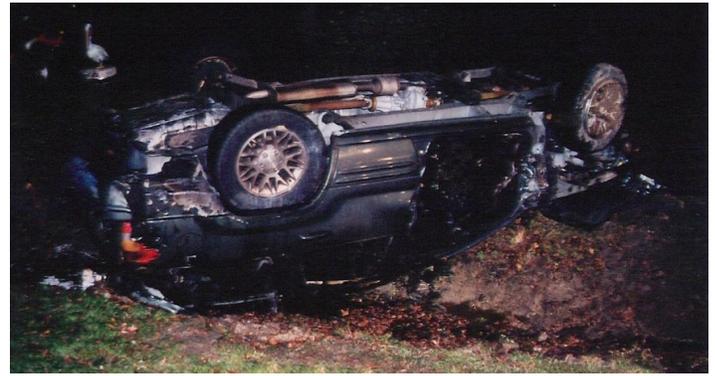
The condition of the seat belt at the driver's seated position indicates that it was most probably not in use. In addition, the seat is partially twisted and forced to the rear consistent with movement of the driver toward the rear of the vehicle.

The passenger seat is comparatively intact and there are indications that the restraint system was in use. The passenger would therefore have been restrained to the passenger seat. Movement of the passenger from the front of the vehicle would not be expected.

The vehicle came to rest upside down. It is likely that the passenger remained belted in position until the fire had consumed the seat belt thereby releasing him. The burn patterns suggest that the passenger side was elevated somewhat over the driver side because of the ditch bank. As the fire consumed the passenger side restraint, the passenger was released. At that point, the passenger would have fallen in the vehicle to a position against the roof toward the driver side. This is the reported position of the owner.

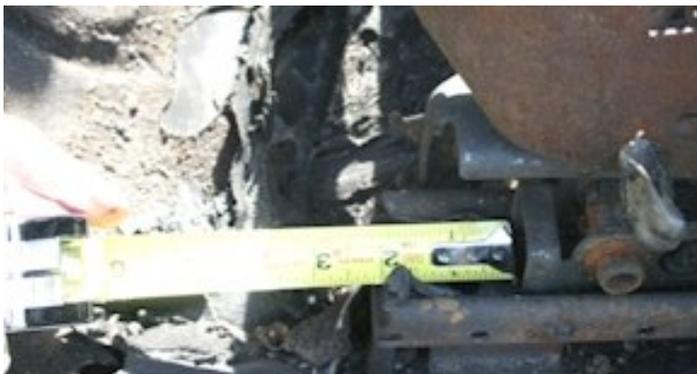
The dynamic motion of the vehicle suggests that the

unrestrained driver would have been propelled toward the rear of the vehicle. Evidence of the rearward movement is found in the damage pattern of the driver seat. With the rear seat folded down, an empty cargo compartment and the vehicle upside down, the driver could readily move rearward to the rear hatch. The final positions of the occupants are therefore consistent with the owner as the passenger and the friend as the driver of the Jeep Cherokee.
